Spring Pin Assembly

PROBLEM: Small pieces of paper being torn off from bottomwrapper paper.

Assure improved operation of your VIPER BOTTOMWRAPPER

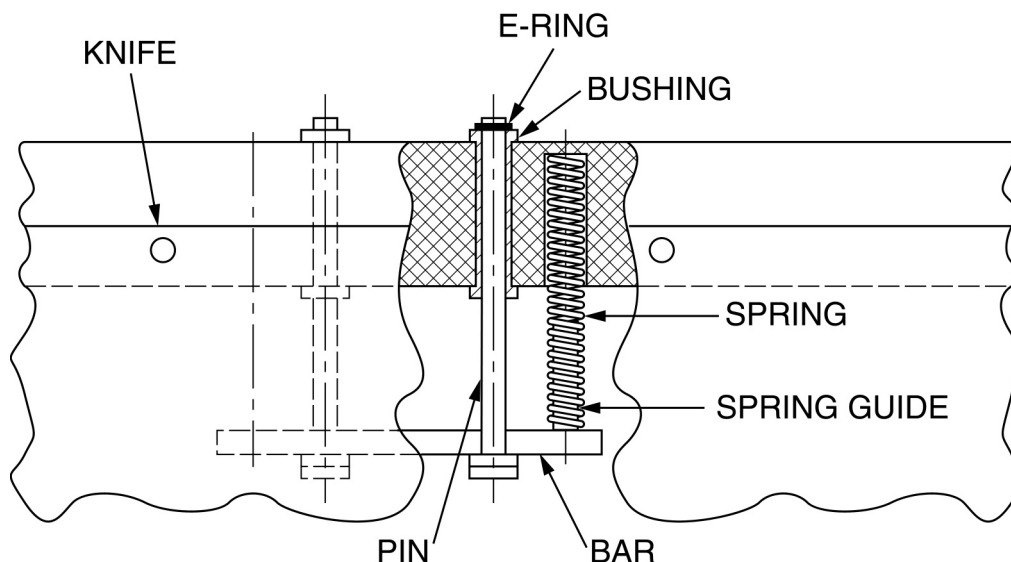
The VIPER Bottomwrapper is supplied with three spring pin assemblies that hold the kraft paper web in places as it cut. Experience indicates that only the center assembly is required to hold the paper. Removing the outer two assemblies will assure even more dependable operation.

Refer to the drawings and observe the following procedure:

1. TURN OFF MACHINE POWER & AIR!
2. Be CAREFUL of the Knife!
3. Swing up the table assembly.
4. Using a small block of wood, carefully push one of the outer spring assemblies back so that the E-rings holding the assembly guide rods in place become accessible.
5. While holding the assembly back, remove the two E-rings with the needle nose pliers.
6. Remove the plate with the rods, the two springs and inner spring guides. The plastic rod bushings may remain in place.
7. Remove the other outer spring assembly in the same manner.
8. Retain the parts as spares, if desired.
